# RESEARCH MEMORANDUM

CYCLIC ENGINE OPERATION OF CAST VITALLIUM TURBINE BLADES  
AT AN EXHAUST-CONE GAS TEMPERATURE OF  $1440 \pm 20^{\circ} \text{F}$

By Charles Yaker and Floyd B. Garrett

September 19, 1949

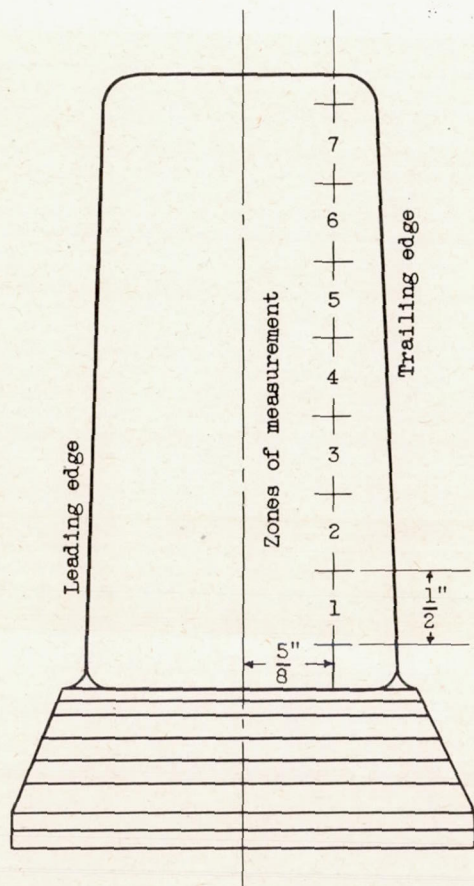
(a) Scribe marks on convex side of turbine blade for use in measuring elongation.

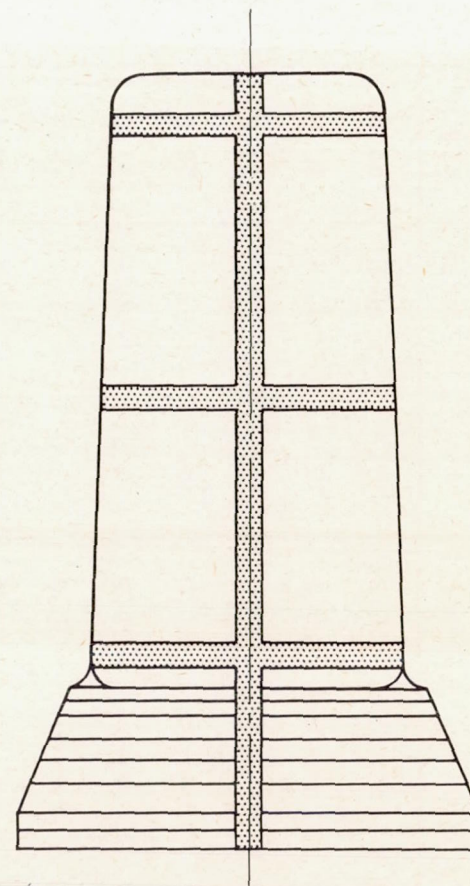
(b) Zones of blade (shaded areas) where Rockwell C hardness measurements were made.

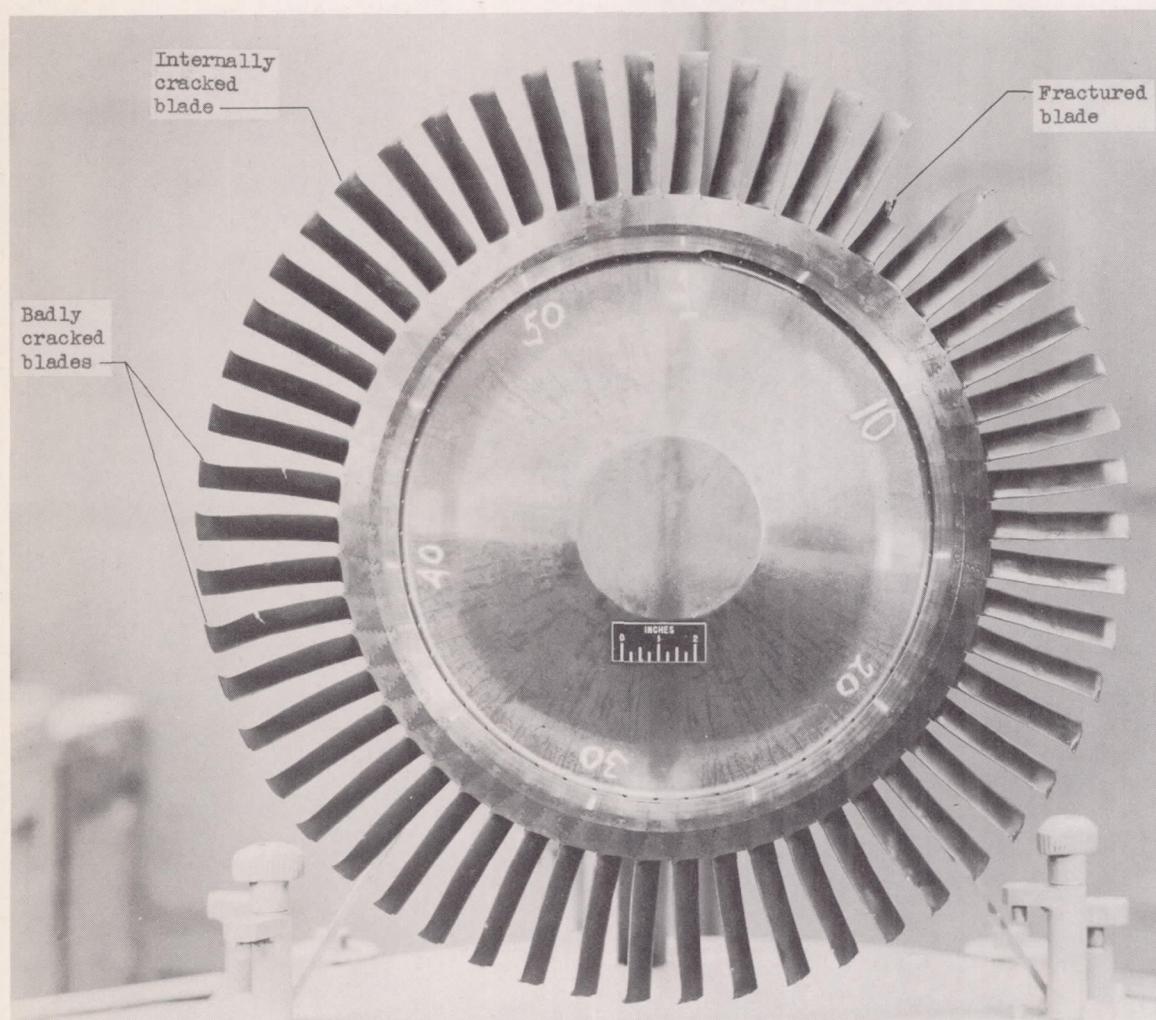
The condition of the four blades that were considered broken because they showed large cracks through the thickness of the airfoil section is presented in table I. The turbine rotor at the conclusion of the run is shown in figure 2; the fractured and cracked blades are shown in figures 3 and 4, respectively.

Figure 2. - Turbine rotor after  $7\frac{1}{2}$  cycles (2 hr, 30 min) of operation.

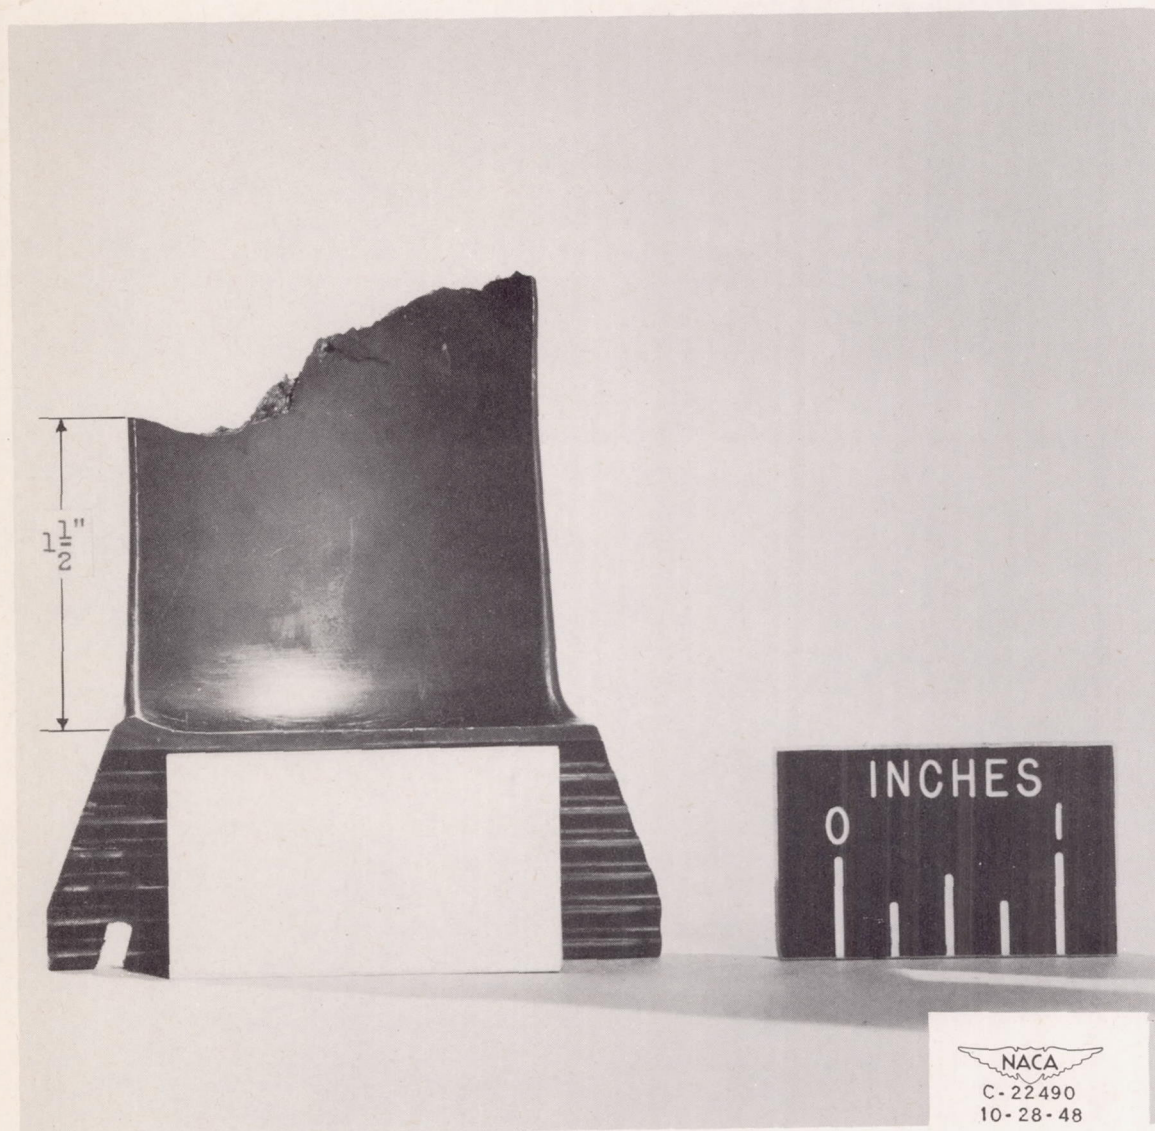
the largest number of failures of cast Vitallium blades have been caused by fatigue. The results of this investigation indicate that fatigue is a cause of blade failure at a higher temperature of operation as well.

Figure 3. - Failure path across fractured blade.

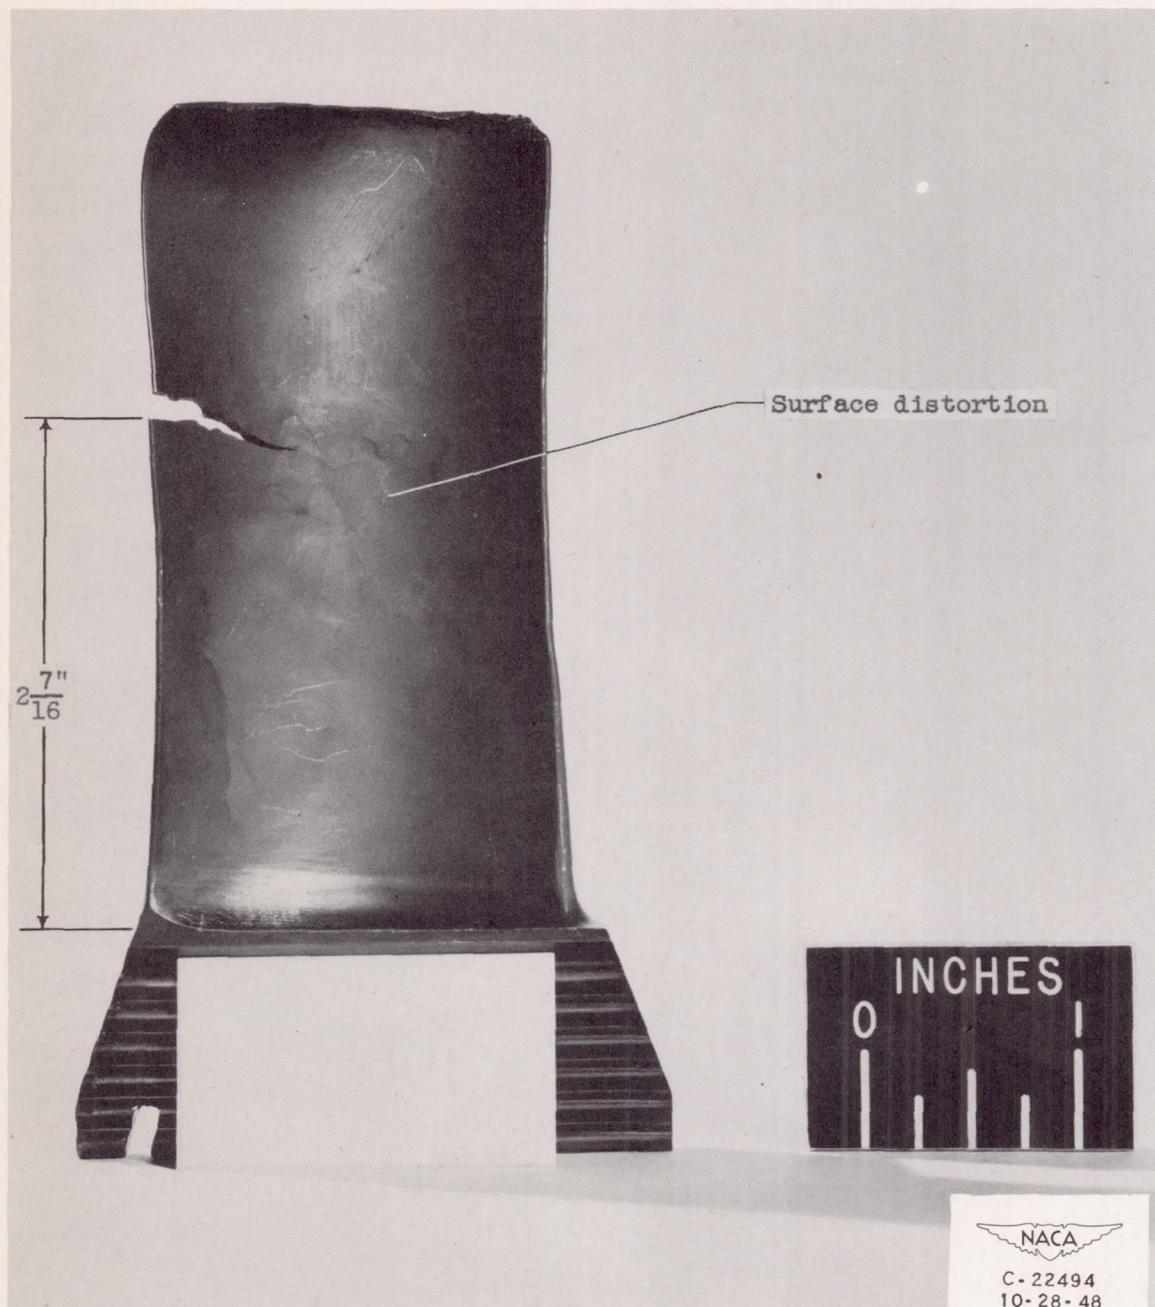
Results of the microexamination of the two blades having large transcrystalline cracks in their trailing edge indicate that they apparently failed by some different mechanism.

Figure 4. - Blade with large crack in trailing edge. Note surface distortion.

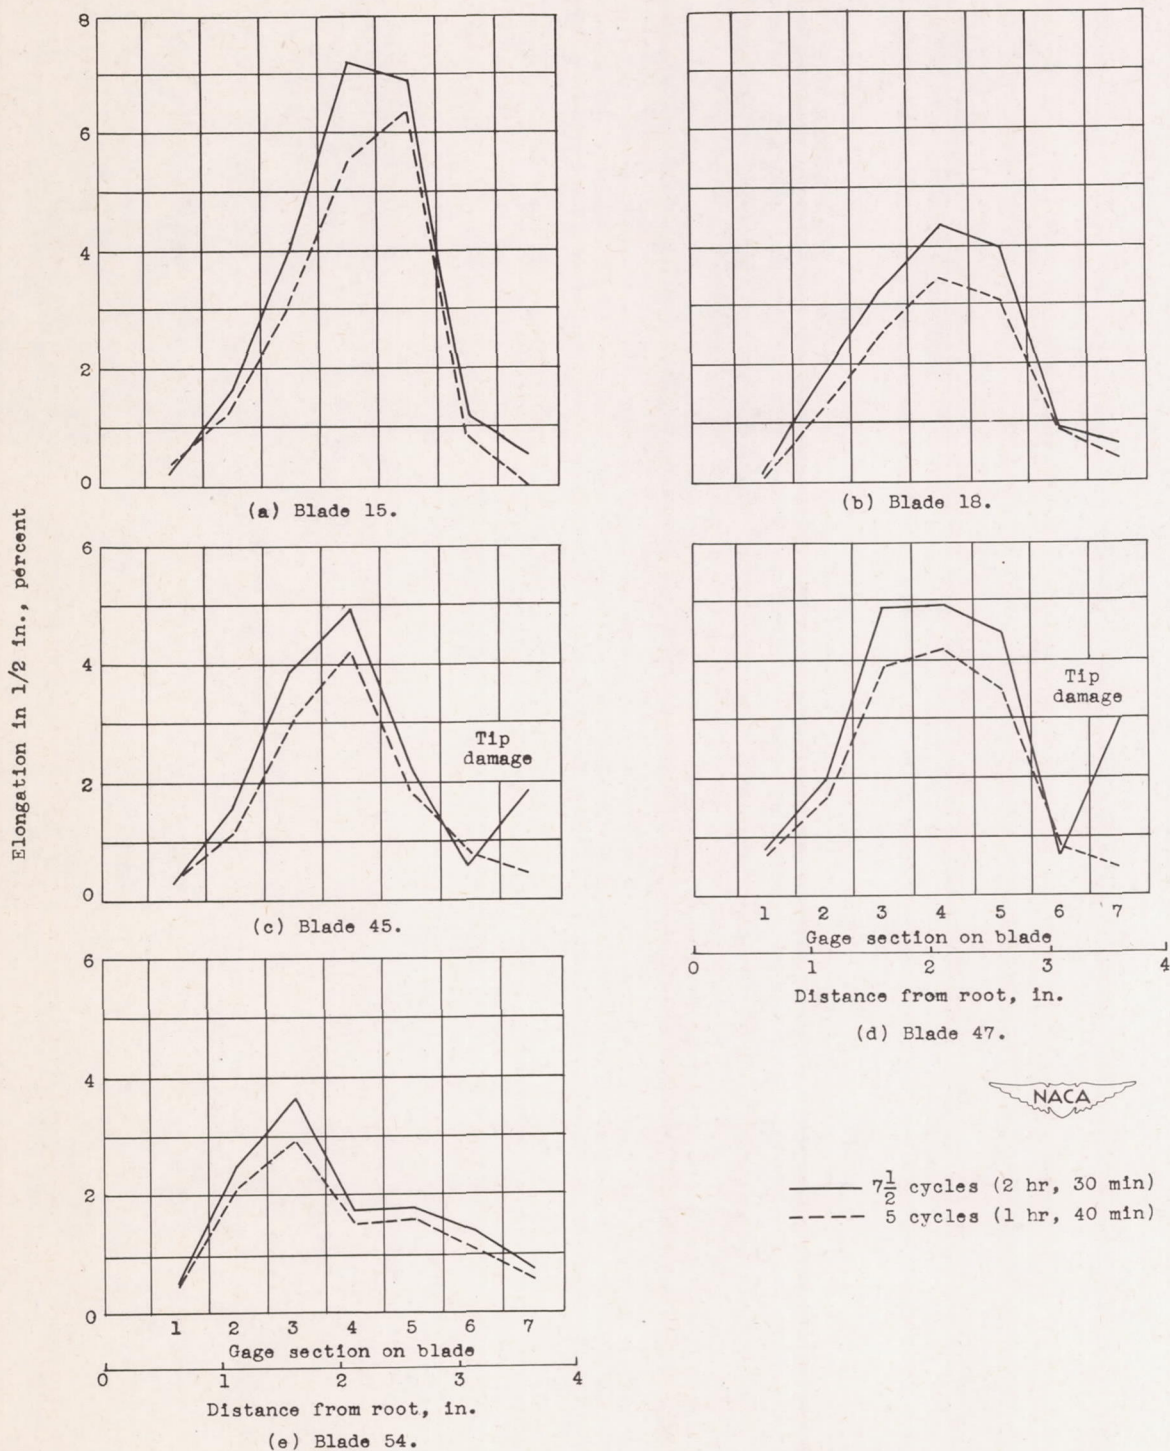
Final elongation measurements were made and plotted with the measurements made at the end of the first 5 cycles (1 hr, 40 min) as percentage elongation in each  $1/2$ -inch-gage length, as shown in figure 5. Total blade elongations were determined and are presented in table II. The over-all blade elongations after  $7\frac{1}{2}$  cycles range from 1.50 to 2.71 percent. From the elongation distributions, it can be seen that the largest portion of the blade elongation (2.37 to 6.04 percent) occurs in the section  $1\frac{3}{8}$  to  $2\frac{7}{8}$  inches from the top of the blade root. A comparison of the elongation in this section with the total elongation is also presented in table II. This comparison indicates that approximately 60 to 84 percent of the total blade elongation occurs in this zone.

Figure 5.- Variation in elongation along airfoil section of blade plotted at midpoint of gage section.

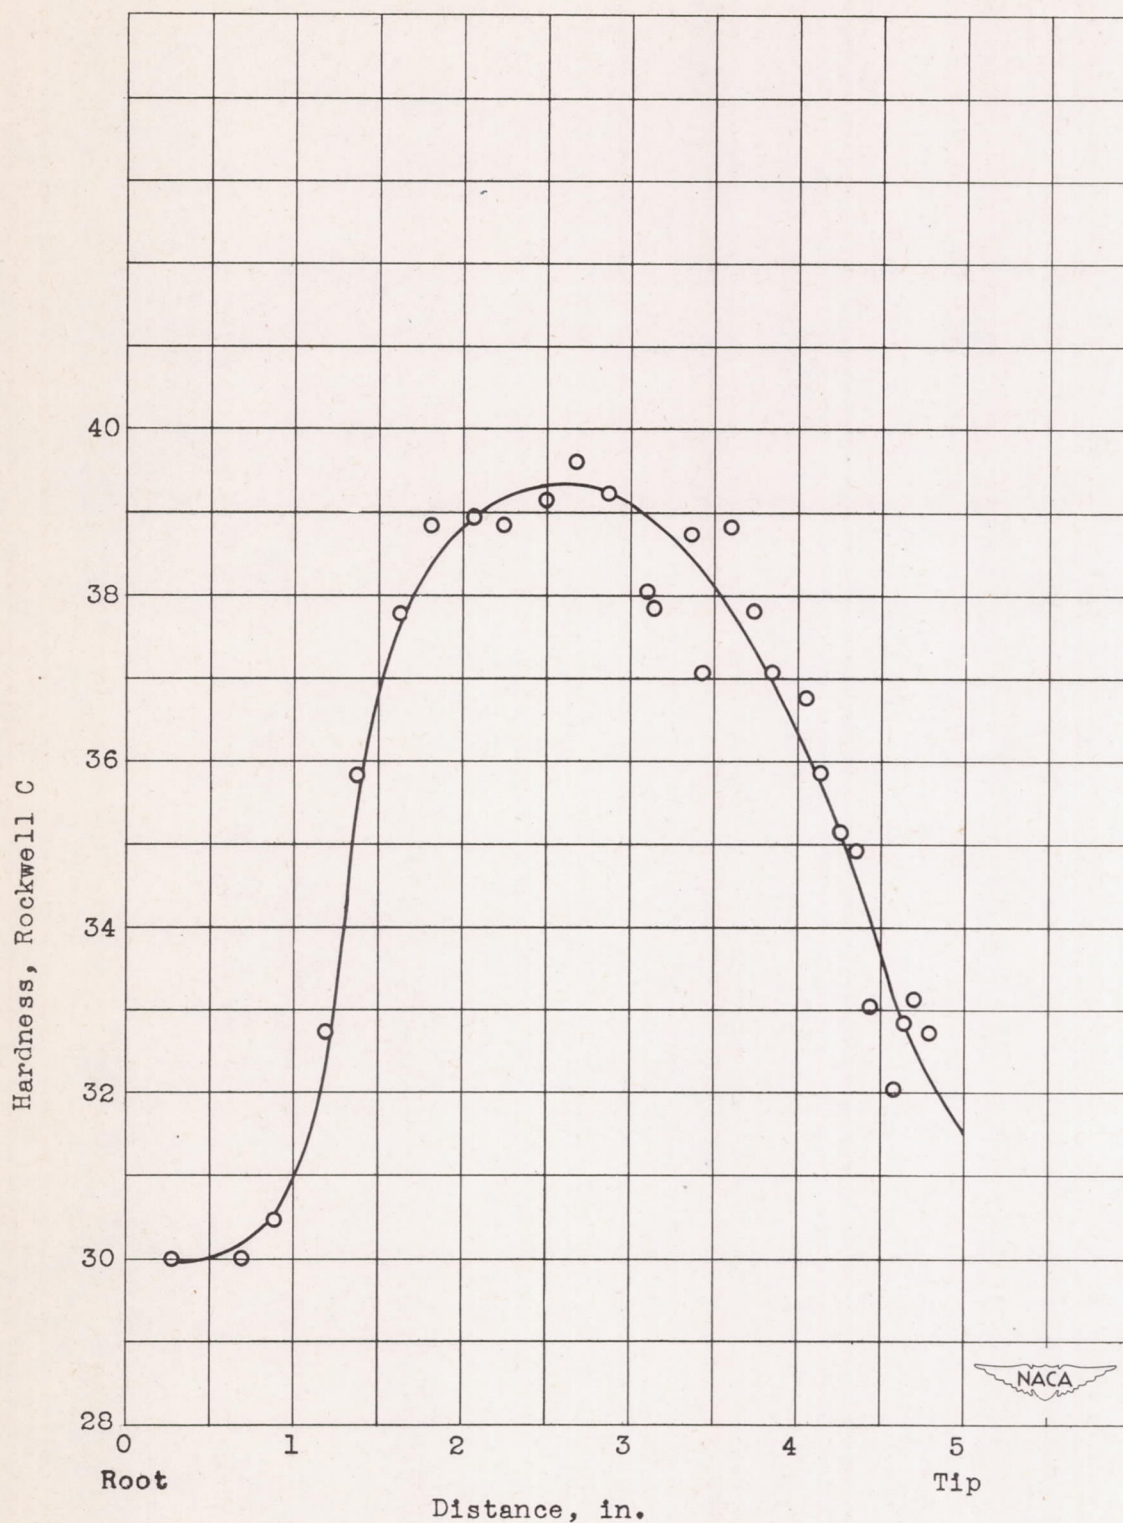
Hardness surveys. The hardness distributions throughout the broken, cracked, and the five unbroken and scribed blades are given in table IV. A typical spanwise hardness distribution along the center of a blade is shown in figure 7. All Rockwell C hardness values

The results of the hardness surveys yielded no correlation between blade failure or elongation and hardness. The hardness variation along the blades (fig. 7) is an indication of the combined effects of stress and temperature distribution in strain and age-hardening the blades during operation.

Figure 7. - Typical hardness distribution along center of blade. (Data points are average hardness values.)

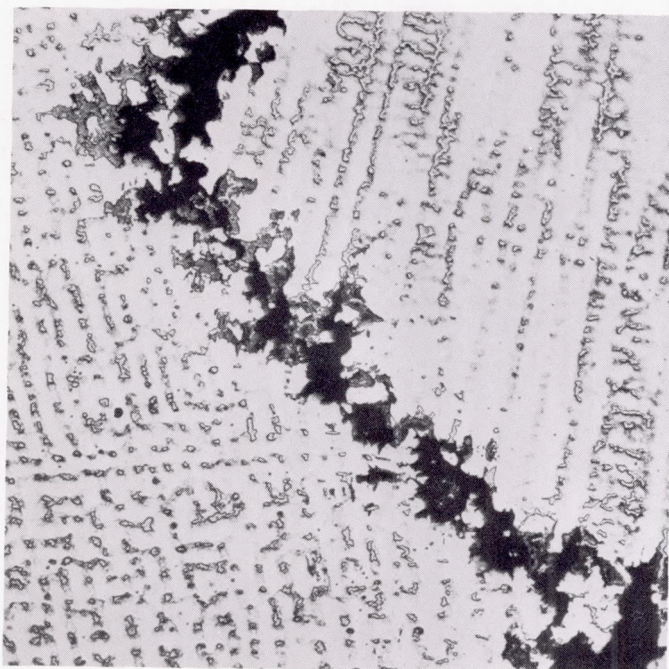
(a) Large intercrystalline crack in blade 48, X50.

Figure 9. - Intercrystalline cracks.

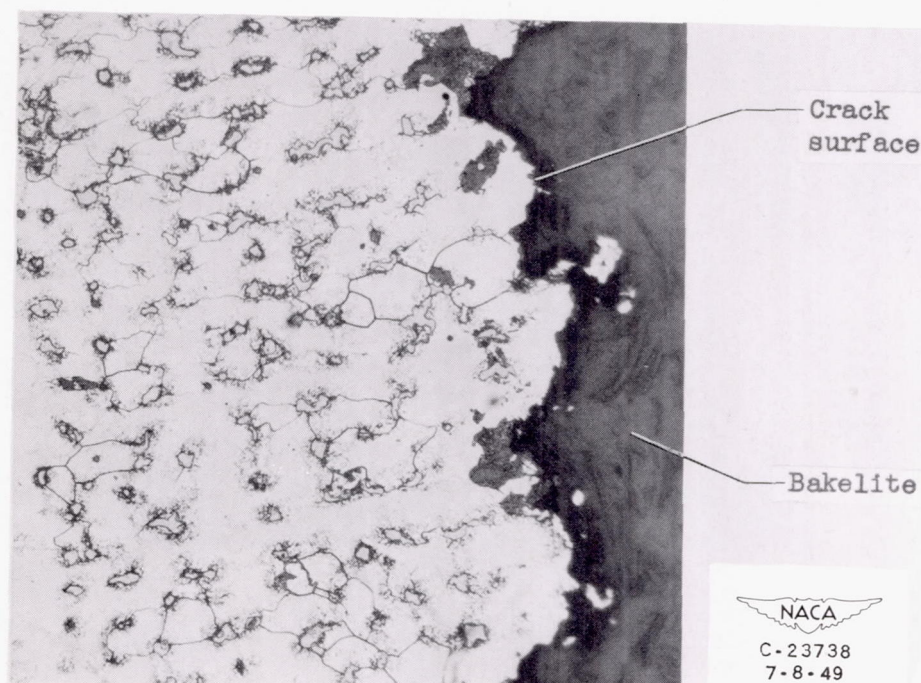
(b) Area alongside crack containing secondary grains, X250.

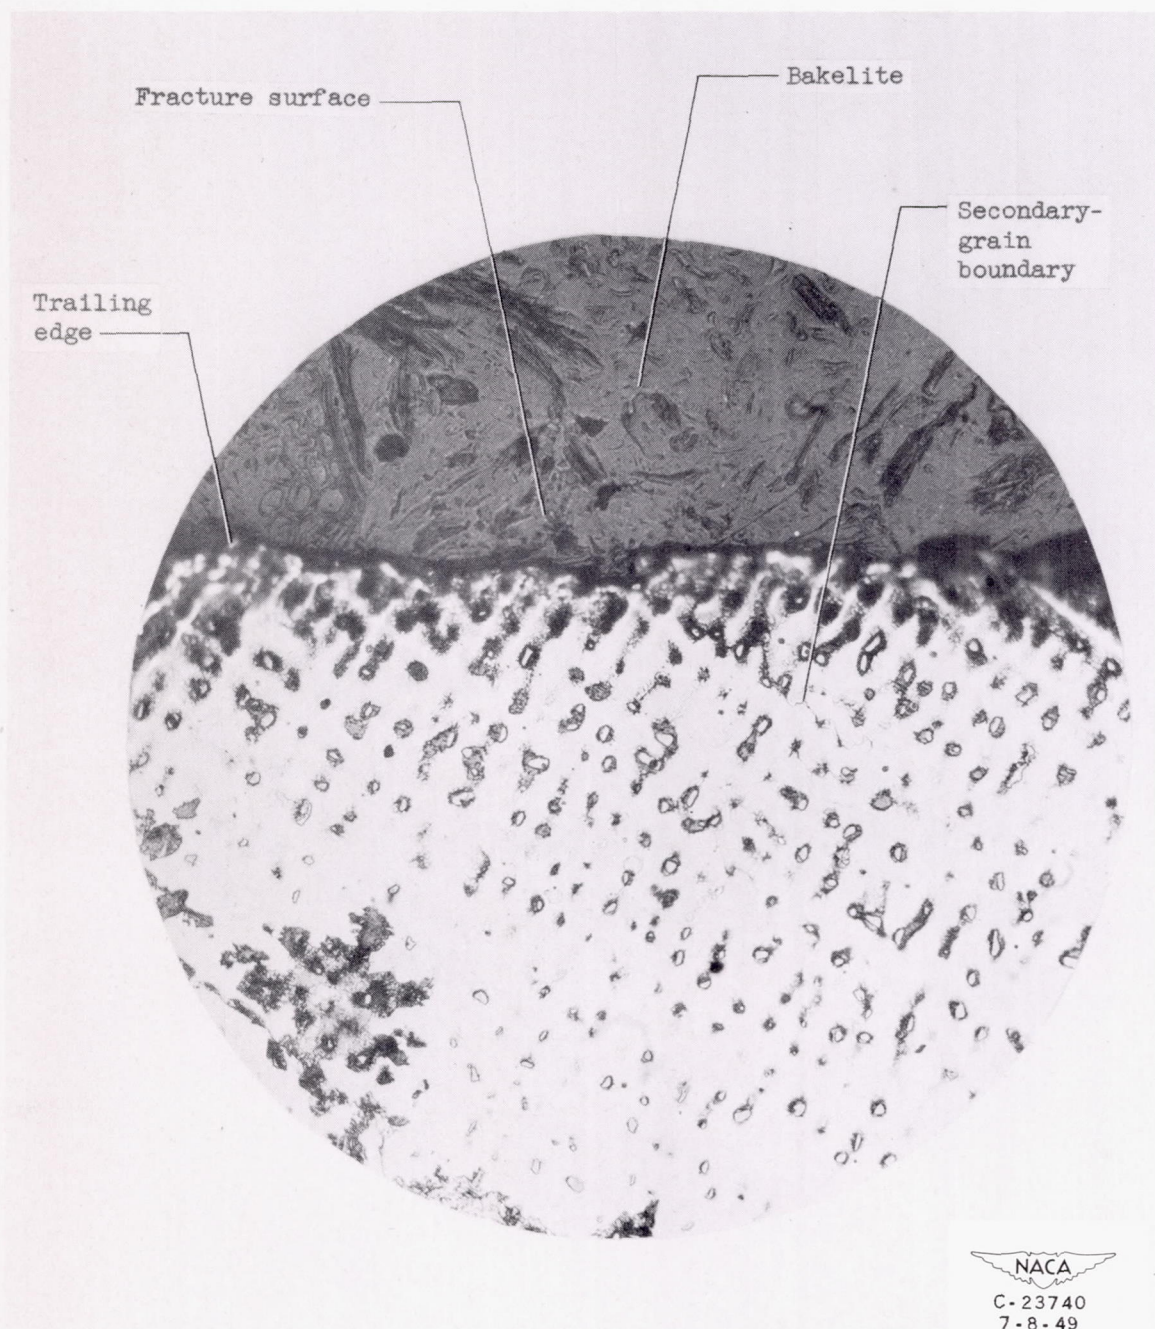
The presence of the secondary-grain boundary in the fatigue-fractured blade (fig. 11) suggests the possibility that the secondary grains and their boundaries, when present in the original unused blades (fig. 10) or formed during operation, might serve as the stress raisers that nucleate a fatigue failure. The intercrystalline cracks might also serve as fatigue nuclei. The presence of secondary grains and intercrystalline cracks suggests that, although cast Vitallium blades have a certain rupture life, they are only suitable for use to a point in the rupture life where the stress raisers within the alloy make it susceptible to fatigue failure.

Figure 11. - Microstructure in zone of fatigue nucleus of blade 6. Note secondary grain boundary, X250.

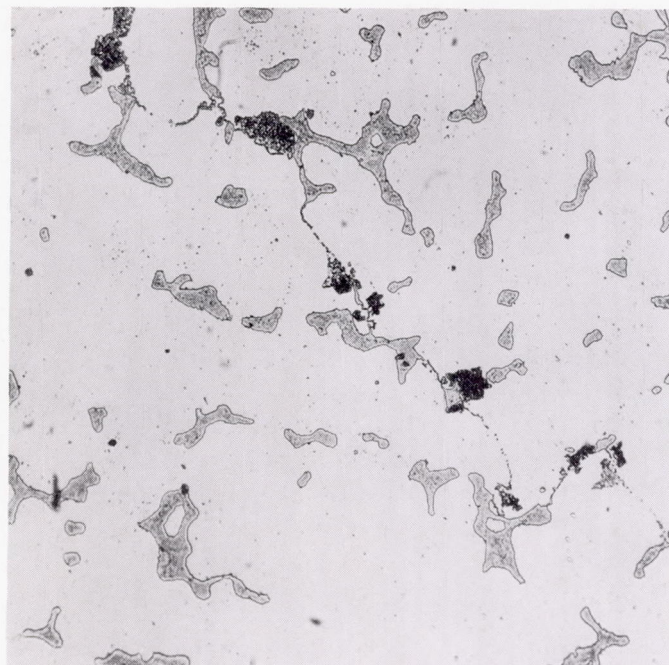
(a) Vitallium before operation. Rockwell C hardness, 30.

Figure 12. - Amount of aging occurring during blade operation, X250.

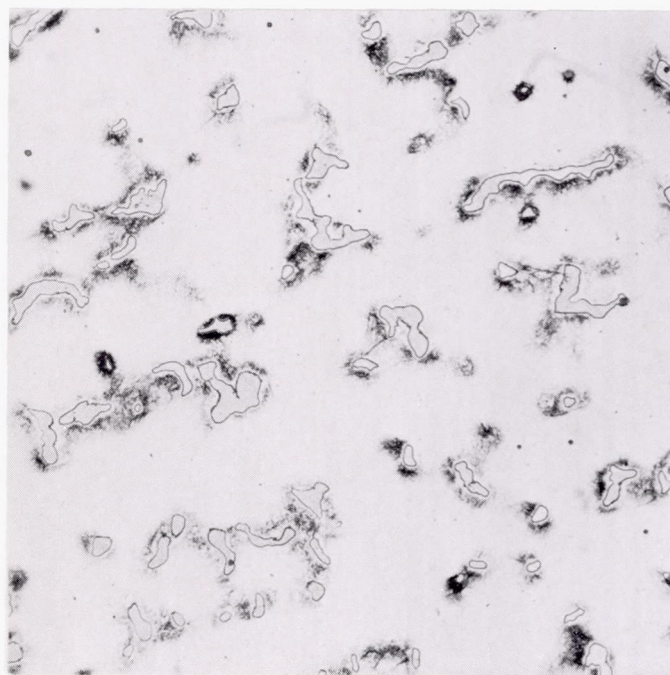
(b) Base of airfoil section. Blade 48; Rockwell C hardness, 34.

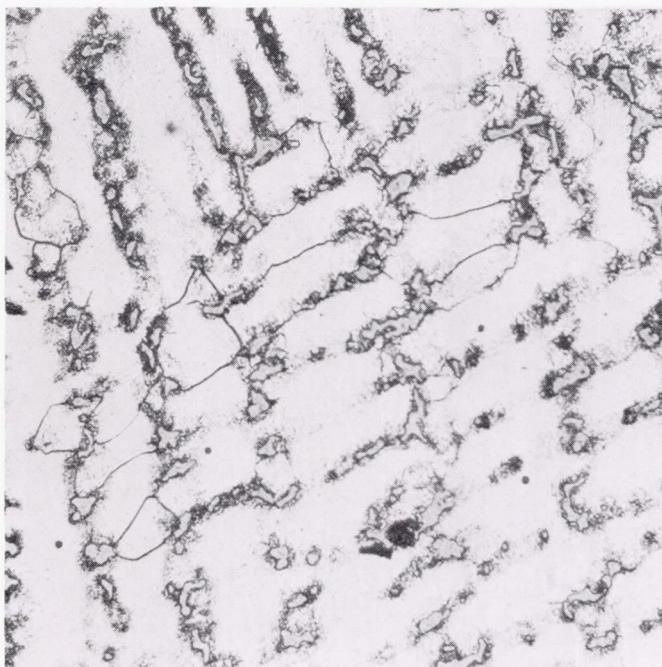
(c) Center of airfoil section. Blade 48; Rockwell C hardness, 40.

Figure 12. - Concluded. Amount of aging occurring during blade operation, X250.

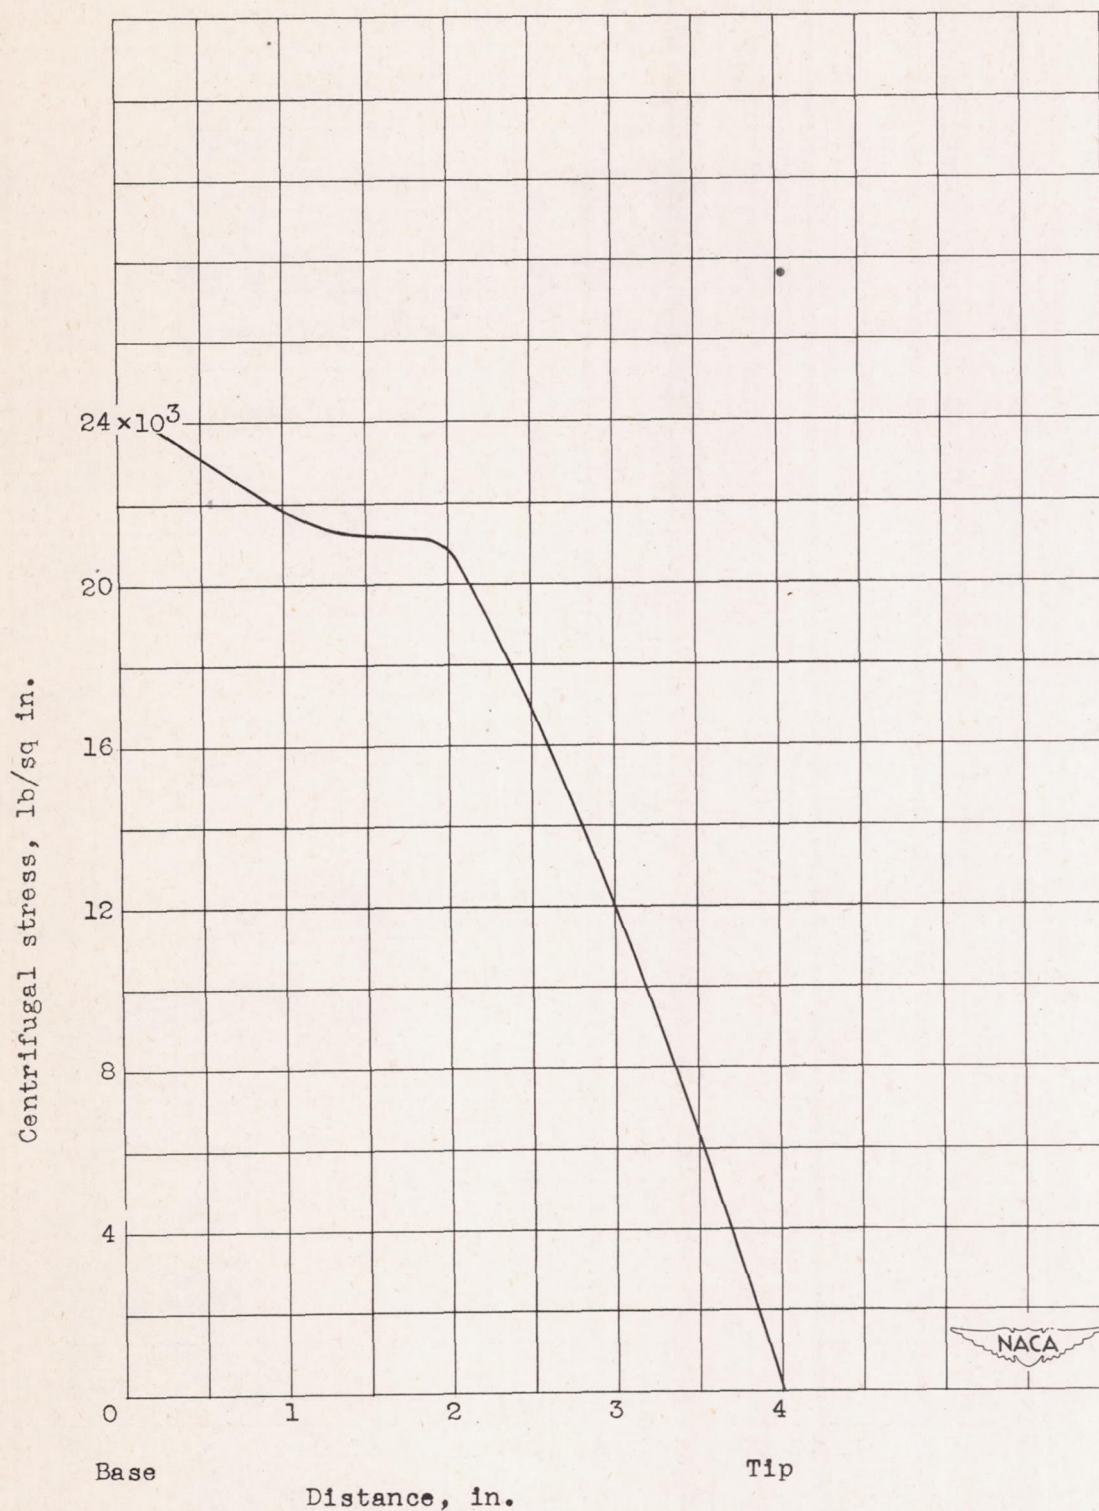
The centrifugal stress distribution in cast Vitallium blades at a turbine speed of 11,500 rpm is shown in figure 13. The maximum temperature of the blades of this investigation can be approximated on the basis of previous temperature surveys at low gas temperatures. By the extension of the curve of maximum blade temperature plotted against average gas temperature at the exhaust-cone outlet (fig. 14), the approximate maximum blade temperature was  $1600^{\circ}\text{F}$  during this evaluation at an average exhaust-cone-outlet temperature of  $1440^{\circ}\text{F}$ . The conditions of engine operation therefore resulted in a stress of about 21,000 pounds per square inch at the midsection of the airfoil section of the blade (fig. 13) and a maximum blade temperature of approximately  $1600^{\circ}\text{F}$ .

Figure 13. - Variation in centrifugal stress in cast Vitallium turbine blade. Turbine speed, 11,500 rpm; radius of turbine rotor, 8.99 inches. (Data obtained from fig. 6 of reference 2.)

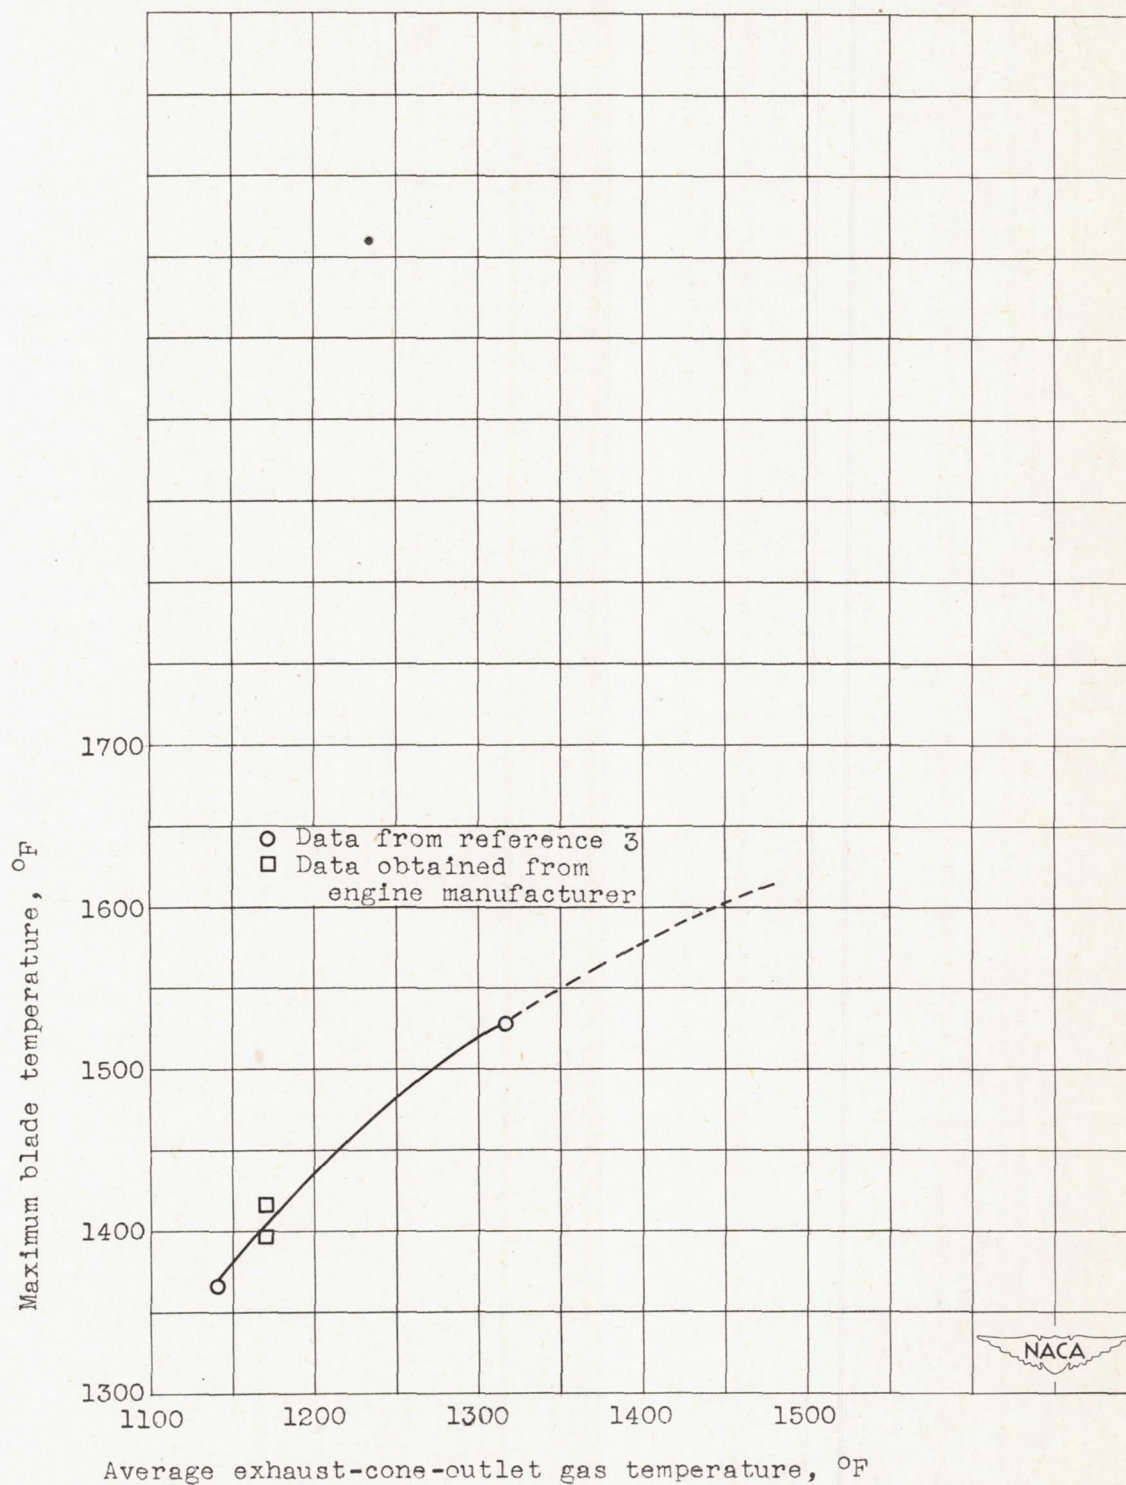
Figure 14. - Variation of maximum blade temperature with average exhaust-cone-outlet gas temperature.

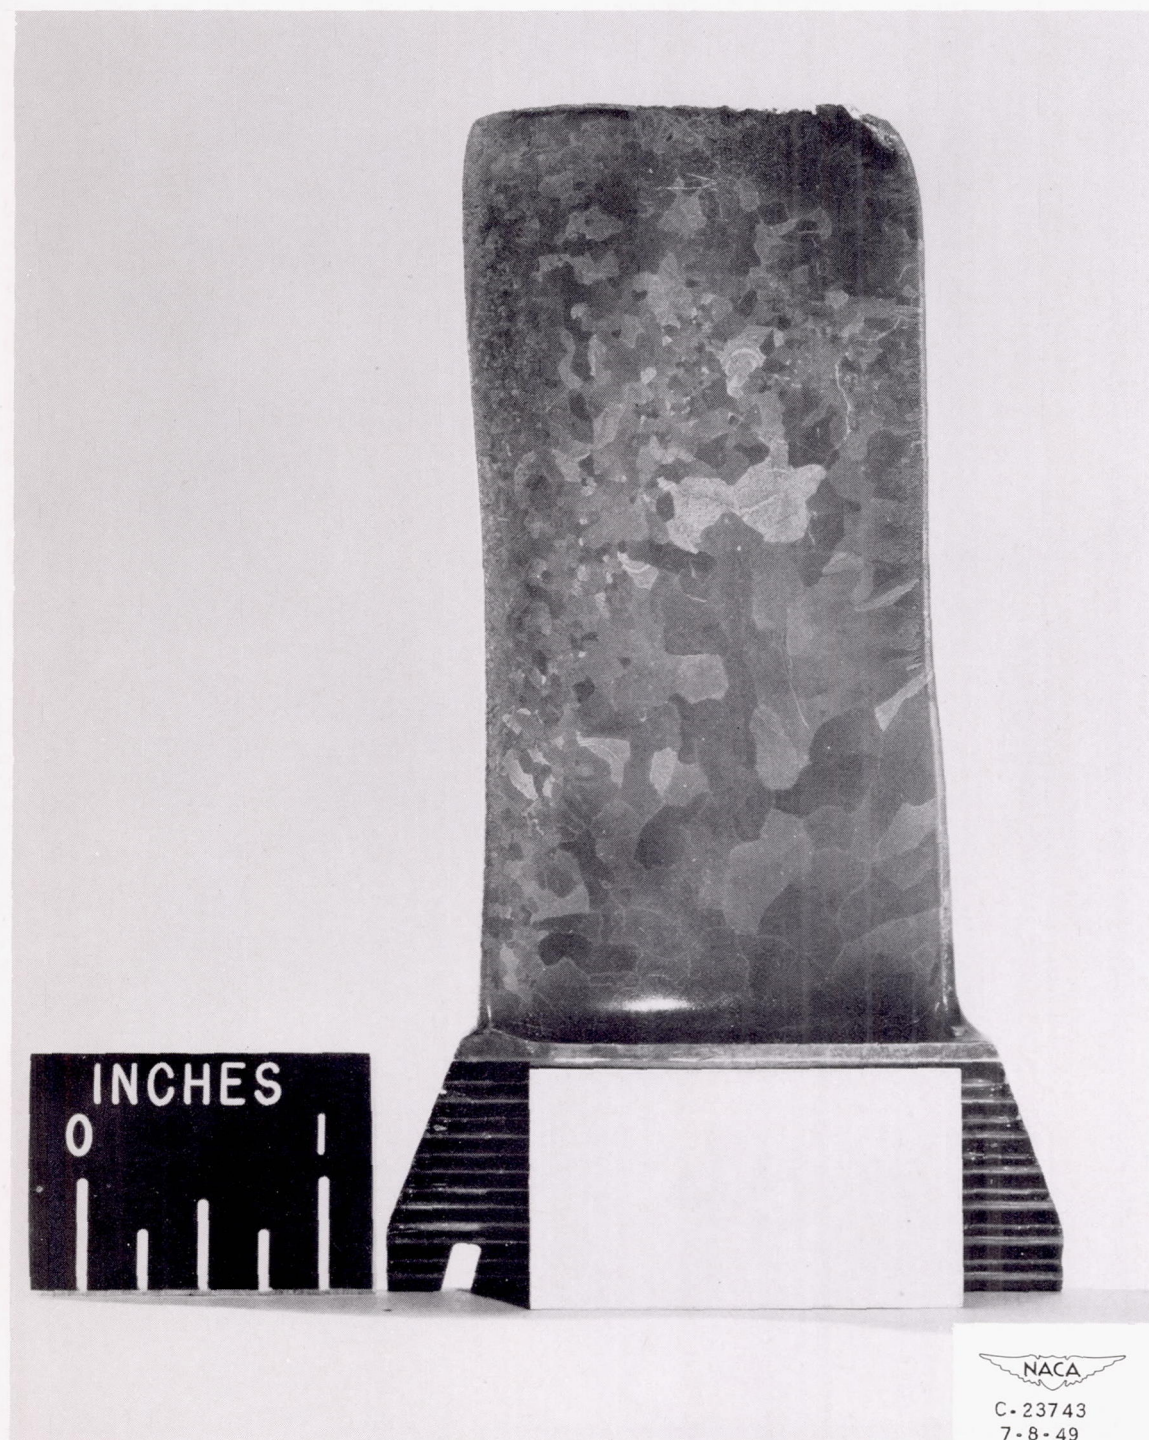
The results of the grain-size measurements failed to produce any relation between blade failure or elongation and grain size, probably because of the wide variation of grain size and orientation within the individual blades. These variations are very likely due to differences in casting variables during blade fabrication. An example of the grain-size variation within a blade is shown in figure 15.

Figure 15. - Grain structure within blade with grain-size range from 4 to 128 grains per square inch. Electrolytically etched in 10-percent hydrochloric acid.
